PLUMBING REPAIRS AT THE BAGHDAD POLICE COLLEGE BAGHDAD, IRAQ

SUSTAINMENT ASSESSMENT

SIGIR PA-08-154 SIGIR PA-08-155 SIGIR PA-08-156

JANUARY 22, 2009

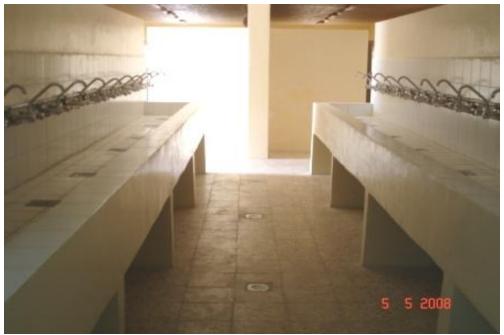
As previously noted, the latrine buildings were turned over to the GOI in May 2008 (Site Photo 1). MNSTC-I and GOI representatives inspected the latrine buildings and found only minor deficiencies. The Assets Recognition Deficiency Report documenting the inspections was issued in Arabic and was translated into English. The deficiencies noted included a broken faucet, a broken toilet siphon, broken water heaters, and touch up work in latrine building A and only touch up work in latrine building B. No other deficiencies were noted.

Site Photo 1. Latrine building A - May 2008 at turnover to GOI (Photo courtesy of MNSTC-I)

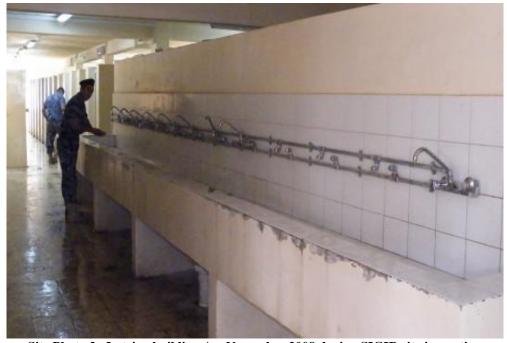
The contract warranty clause provides that, "The Contractor shall also provide one-month of classroom and on the job training for all onsite equipment, and warranty and operations and maintenance oversight for a period of twelve months." However, the extensive vandalism damage and the widespread apparent theft of plumbing, heating, and ventilation equipment has rendered warranty provisions for the two new latrine buildings unenforceable (Site Photo 2).

Site Photo 2. Latrine building A – November 2008 during SIGIR site inspection

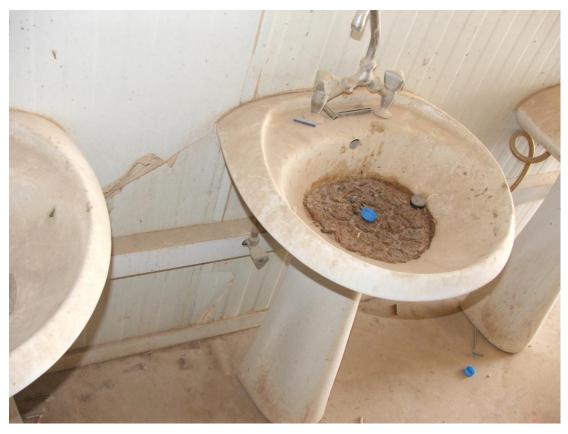
The latrine trailers were new when delivered and installed. Site Photo 3 shows a latrine trailer at the time it was delivered and installed. Site photo 4 shows a latrine trailer at the time of the site inspection on 25 November 2008.

Site Photo 4. Latrine trailer at the time of the SIGIR site inspection on 25 November 2008.

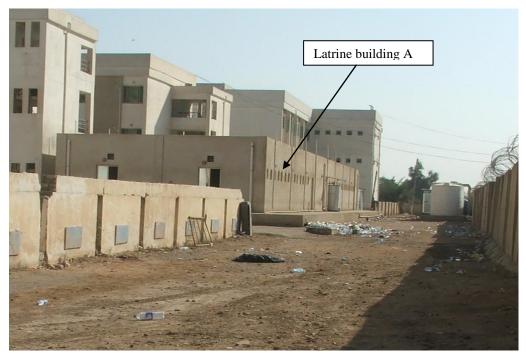
In order to provide sufficient toilets, showers, and hand-and-foot washing stations for the occupants of the eight cadet barracks, two new single-story latrine buildings were constructed. The newly constructed latrine buildings were placed in the center of the two quads formed by the eight cadet barracks. Site Photo 5 shows latrine building A. Site Photo 6 shows latrine building B.

Site Photo 5. Latrine building A and its water heaters placed between cadet barracks

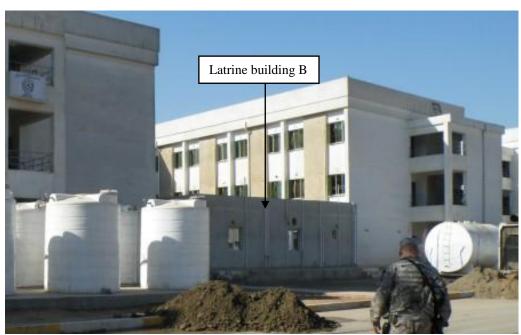
Site Photo 6. Latrine building B, between cadet barracks

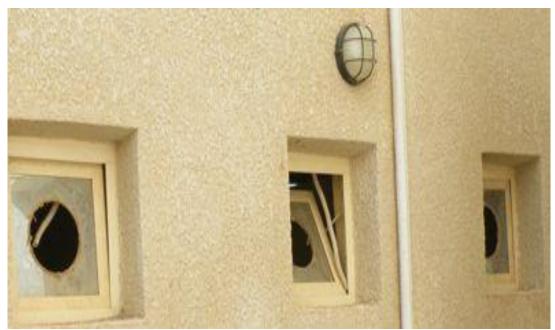
In the latrine buildings, there was extensive vandalism and theft of fixtures including exhaust fans torn out of the windows (Site Photo 7), shower pipes bent beyond use (Site Photo 8), faucets removed from hand-and-foot washing stations and capped off (Site Photo 2), and toilet flush tanks torn off the walls. Site Photo 9 shows toilets at the time of turn over to the Government of Iraq (GOI) in May 2008. Site Photo 10 shows a toilet at the time of the site inspection on 25 November 2008. In a number of instances, the shower stalls in the newly built latrine buildings had shower head piping bent over in an

Site Photo 7. Exhaust fans were removed from new latrine buildings

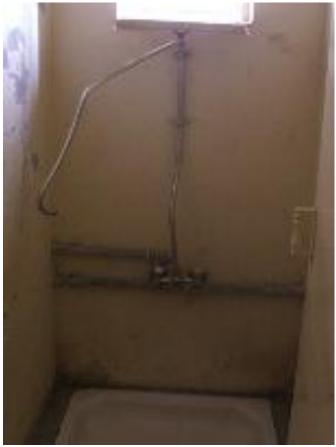
Site Photo 8. Vandalized showers - latrine building B

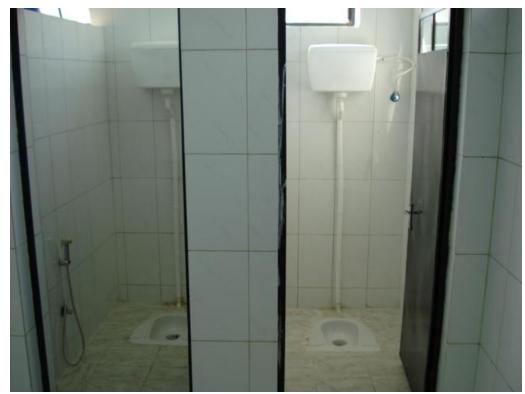
Site Photo 9. Toilet in new latrine building at turnover to GOI in May 2008 (Photo courtesy of MNSTC-I)

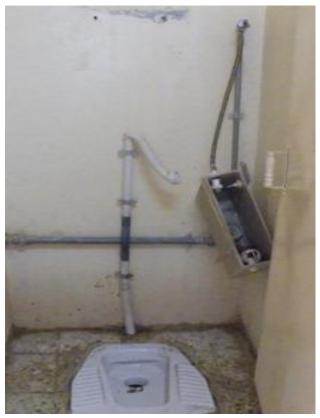
unusable condition. The inside of the building had missing, or extensive damage to the plumbing fixtures.

Site Photo 10. Toilet in the new latrine building during the SIGIR site inspection (11-25-08)

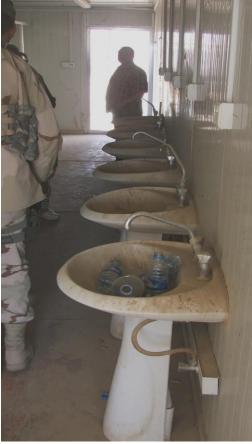
SIGIR inspectors observed the latrine trailers during the inspection on 25 November 2008 (Site Photo 11 and 12). The eight latrine trailers were particularly filthy, thereby creating a health hazard. In response to the vandalism, MNSTC-I and the GOI have taken actions to minimize future issues with respect to construction. These actions include building stand alone latrines separate form barracks to separate the plumbing and potential for water and sewage damage in living areas and transfer buildings to specific GOI agencies and organizations. Specific Iraqi ownership has improved the operations and maintenance of the facilities. Installing gravity-fed water systems where practicable to account for uncertainty in the electrical systems to ensure potable water is still available when needed.

Site Photo 11. Condition of hand-and-foot washing stations in latrine trailer.

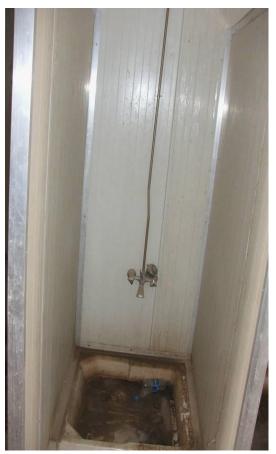
Site Photo 12. Condition of shower in latrine trailer.
